TO: HOLDERS OF ULTRA ELECTRONICS SERVICE BULLETIN 6647-32-6

## SERVICE BULLETIN No. 6647-32-6

### LANDING GEAR - EXTENSION AND RETRACTION - CONTROL AND INTERFACE

#### MODIFICATION No. 4

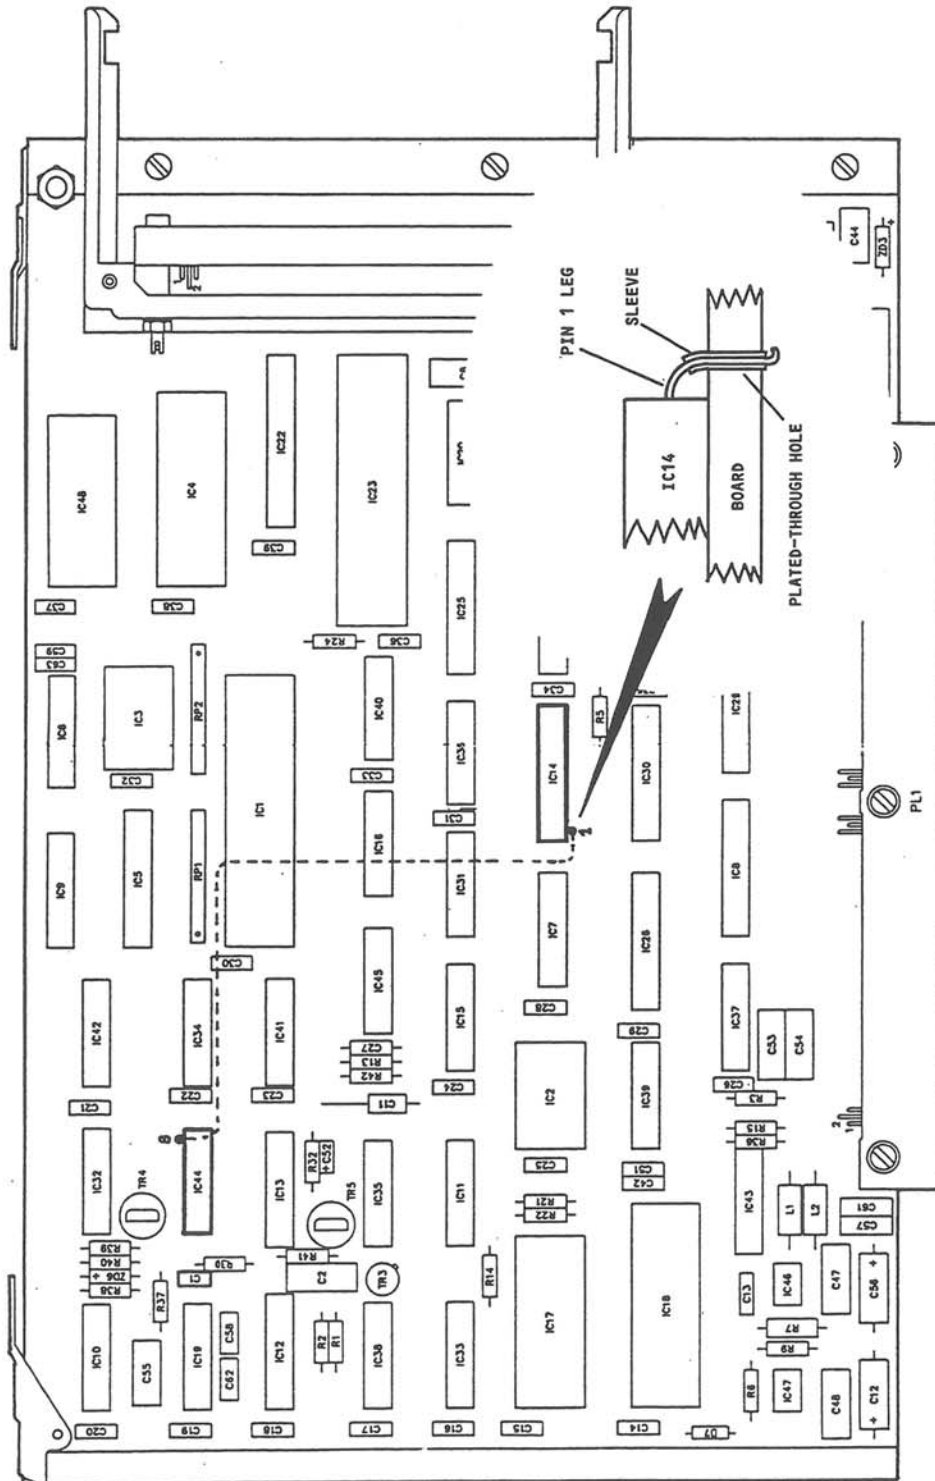
Microprocessor PCB - Modification No. 4  
Figure 1

Capacitor C1 controls the timing of the first ARINC transmission after power-up. Changes of tolerance spread of C1 may cause problems during subsequent test. Modification No. 4 replaces C1 with a capacitor of lower value which will prevent test problems.

The integrated circuit latch IC14 controls the SELECT OUT pulse which is enabled during lane change. Again, tolerance spread in IC14 may cause problems during subsequent test. These problems occur because IC14 does not have a defined reset state. Modification No. 4 replaces IC14 with a different component which can be reset by a signal from the microprocessor. Test problems will not occur with the new IC14.

- (1) Refer to Fig. 1 and find IC14 and C1 on the PCB.
- (2) Apply small drops of toluene from a small brush on to the area of the conformal coating near IC14 and C1.
- (3) Stop for one to two minutes.
- (4) Clean the area with a strong, natural-bristle brush.
- (5) If necessary, apply more toluene and clean the area again.
- (6) Dry the area and then apply iso-propyl alcohol to the area to remove the toluene.
- (7) Do the procedures in sub-paras. (2) to (6) on the other side of the PCB.
- (8) Unsolder and remove IC14 and C1. Use a desolder tool to remove all solder from the plated-through holes.
- (9) Discard IC14 and C1.
- (10) Unsolder, remove and discard the wire link between pin 1 of IC14 and pin 8 of IC7.

- (1) Take the components from the Modification Kit, Pt. No. 001-LG-01-K010.
- (2) Install the new C1 on the PCB and solder in position.
- (3) Install the new IC14 on the PCB but do not solder its legs.
- (4) Refer to Fig. 1. Install the PTFE sleeve (in the Mod. Kit) over IC14 pin 1 leg and push the sleeve through the plated-through hole until it touches the IC body.
- (5) Cut the sleeve to the correct length and make a hook in the end of pin 1 leg. Make sure that there is no contact between pin 1 leg and the PCB track.
- (6) Solder all the IC legs except pin 1 to their track pads.

- (9) Refer to Fig. 1. Put the wire in position on the non-component side of the PCB, between IC14 and IC44.
- (10) Cut the wire to the correct length and remove a small part of the insulation. Solder the wire to pin 8 of IC44, on the non-component side of the PCB.
