SERVICE BULLETIN No. 6647-32-9

LANDING GEAR - EXTENSION AND RETRACTION - CONTROL AND INTERFACE

POWER SUPPLY/FILTER ASSEMBLY - PRECAUTIONARY REPLACEMENT OF GROMMETS

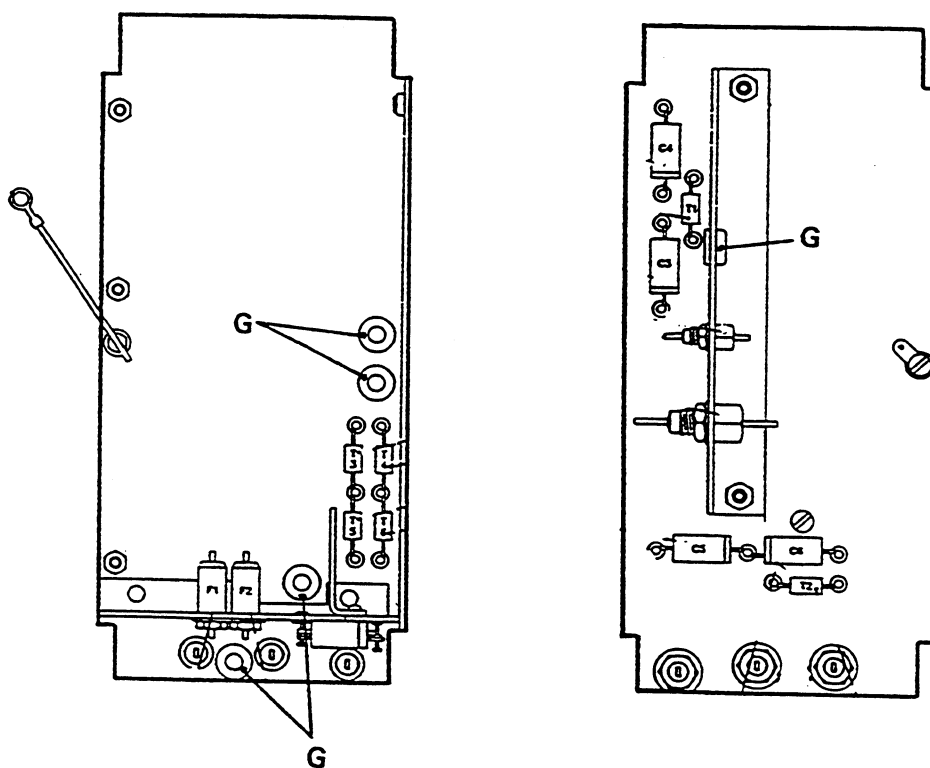
Figure 1 Power Supply/Filter Assembly - Grommet Positions

Five insulating grommets used in the power supply/filter assembly, Pt. No. 001LG010380 have been found to exhibit a tendency to hardening and subsequent cracking after extended service.

- (1) Remove three M3 screws (150), two M3 nuts (155), two lock washers (160) and two plain washers (165) which secure the power supply module (145) to the power supply/filter assembly (135).
- (2) Refer to Fig. 1 of this Service Bulletin and identify the five grommets (letter G). At this stage you should be able to gain access to all five grommets without further disassembly.

- (1) Identify the wires which you must unsolder in order to fit the new grommets. Tag these wires and make a note of the routing of each wire.
- (2) Taking each grommet in turn, unsolder the relevant wires, remove and discard the original grommet.
- (3) Fit the new grommet and resolder the wires. Renew any cable ties which you have had to cut.
- (4) Repeat this procedure until all five grommets have been replaced.
