## SERVICE INFORMATION LETTER LG 05/03

### LANDING GEAR CONTROL AND INTERFACE UNITS 6647 SERIES

(Used on A318, A319, A320 and A321 Aircraft)

#### CORRECTIVE ACTION FOR CRACKED SOLDER JOINTS ON TRANSISTORS

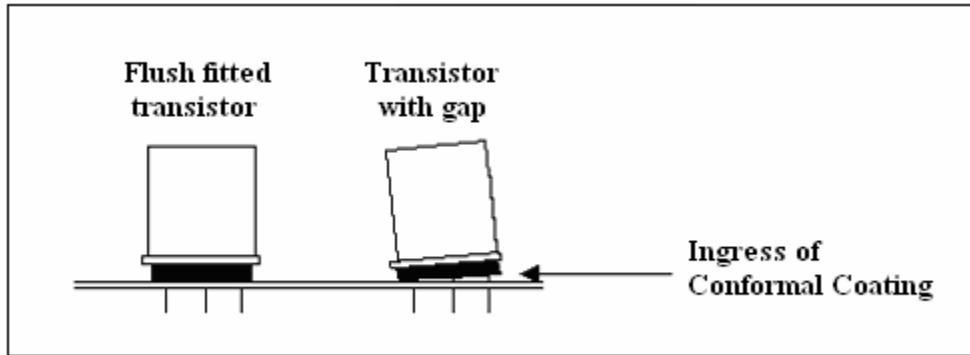
Figure 1

Each transistor is fitted on a thin spacer. The probable failure mechanism is due to the ingress of conformal coating beneath some transistors. This is a result of production variations that can, in some instances, allow a gap beneath the transistor into which conformal coating can penetrate. The coating expands and contracts with temperature changes, causing stress cycles that eventually crack the solder joint. (See Fig. 1)

If an assembly is returned from service with cracked solder joints on a T0-5 / TO-39 style transistor, it is not sufficient to simply re-solder the joints.

Although at the time of rework they would be sound, the conditions that led to the crack are still present, and after further temperature cycles the joint will fail again.

- Clear coating (1-2577) from PCB solder side in transistor location.
  - De-solder joints.
  - Remove transistor (with heatsink still attached).
  - Carefully clean coating from the PCB. Use Toluene to soften the coating, then a soft scraper to remove it from the PCB. Ensure the plated-through-holes are uncontaminated.

- Place the transistor(s) in a small container of Toluene for 5 – 10 minutes.
  - Remove the pad and the coating on the underside of the transistor. Discard the pad.

- Thoroughly clean the transistor's underside, and the leads.
  - Fit new pad (P/N 28682-193-0-8) and ensure all items are flush to the board.
  - Fit transistor, then solder leads and clean joints using IPA (Isopropyl Alcohol).

- Re-coat with conformal coating on solder side of PCB.
  - Coat the top of the transistor around the heatsink, as this aids its retention.
- Sparingly** re-coat the sides of the transistor.
