SERVICE BULLETIN

SERVICE BULLETIN No. 6647-32-5

LANDING GEAR - EXTENSION AND RETRACTION - CONTROL AND INTERFACE

INTRODUCTION OF LGCIU Pt. No. 664700500A4B

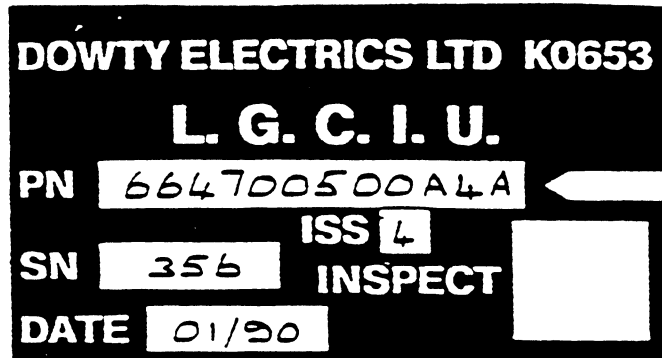
Some LGCIUs have entered service with an incorrect Part Number written on the unit identification label on the front panel. These units have the legend '664700500A4A' written in the PN space on the unit label. The correct legend is '664700500A', the final two digits of the LGCIU Part Number being obtained from the label on the relevant OBRM.

(a) LGCIU Label showing incorrect Part Number

Refer to Fig. 1. If the PN space on the LGCIU identification label carries the legend shown in Fig. 1(b), no action is required. If, however, the legend is '664700500A4A', as shown in Fig. 1(a), proceed as follows :-

- (1) Using a lint-free cloth moistened with iso-propyl alcohol, wipe away any dirt and finger-marks from the LGCIU front panel label.
- (2) Using a small brush loaded with black enamel lacquer to AFS307 (or the equivalent), obliterate the digits '4A', as shown in Fig. 1(b).

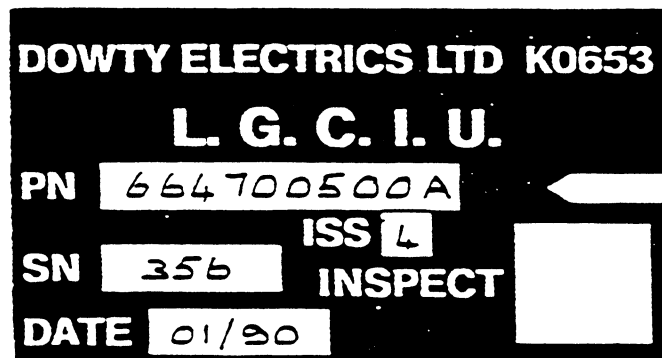
(b) LGCIU Label showing correct Part Number
