SERVICE BULLETIN No. 005LG-32-1

LANDING GEAR - EXTENSION AND RETRACTION - CONTROL AND INTERFACE

DOWNLOCK INDICATOR LAMPS - IMPROVED POWER SUPPLY ISOLATION

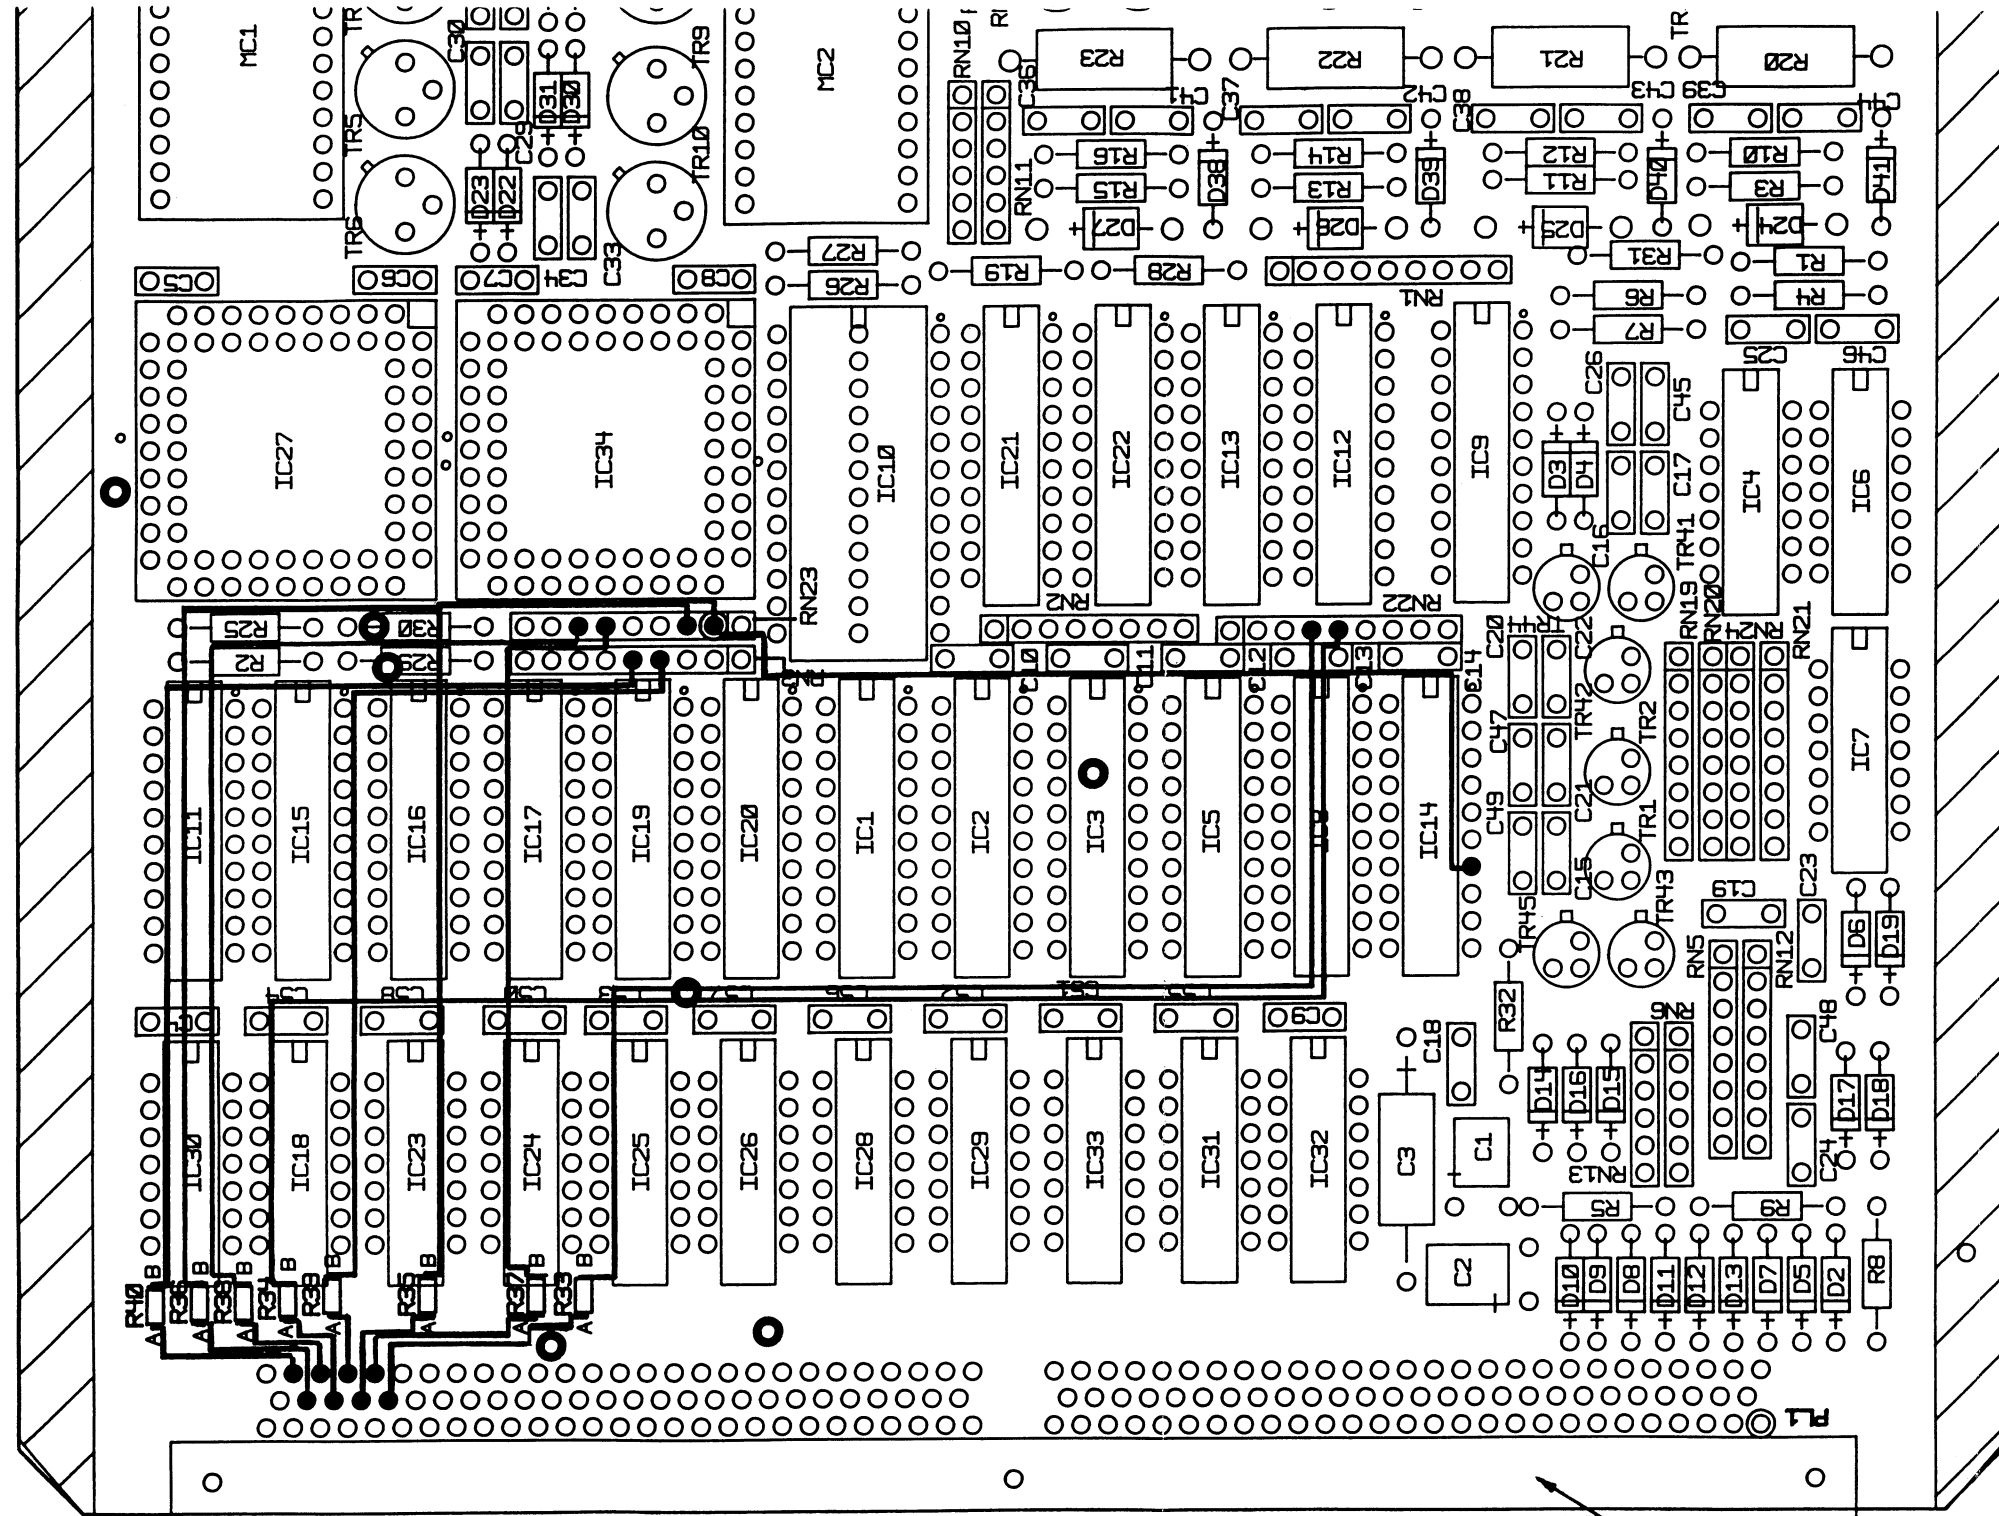
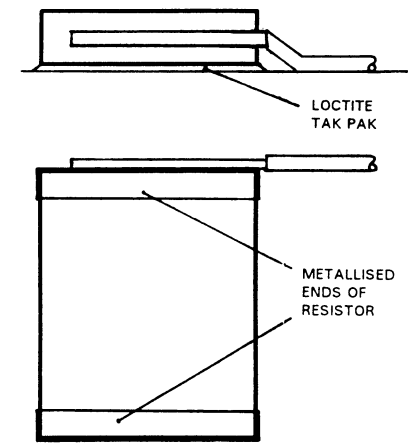
Figure 1 Control PCB - Additional Resistors and Links

These supplies and circuits are intended to be electrically isolated from each other such that they can work independently of each other. Production experience indicates

that this isolation can be degraded due to a build-up of circuit tolerances. In this event a small number of units may be unable to power the independent DOWNLOCK lamps when the normal supply is disconnected.

This Service Bulletin introduces the precautionary addition of eight resistors on the Control PCB (Pt. No. 005LG00-0350). The extra resistance thus introduced restores sufficient isolation between the normal and the independent supplies and circuits.

- (1) Refer to Fig. 1 at the end of this Service Bulletin and compare this illustration with the unmodified Control PCB.
- (2) Note that the eight resistors, R33 thru R40, and all the wire links, are fitted on the solder side of the PCB.
- (3) Locate the seven VIA holes (shown as ● on Fig. 1) and identify the corresponding locations on the PCB.
- (4) Locate the solder pad in position 2 of RN23 (shown as ● on Fig. 1) and identify the same pad on the PCB.
- (5) Locate the solder pads to which the wire links will be soldered (shown as ● on Fig. 1) and identify the same pads on the PCB.

- (1) Select a sharp 1.5mm diameter PCB drill.
- (2) Drill out the seven VIA holes (shown as ● on Fig. 1).
- (3) Drill out the solder pad in position 2 of RN23 (shown as ● on Fig. 1).
- (4) Using a dry, clean air blast, remove all cutting swarf from the work areas.
- (5) Using an illuminated PCB-hole magnifier, make sure that all traces of the plated-through walls have been removed. Make sure that no dirt or swarf remains inside the drilled-out holes.

- (1) Turn the PCB so that the solder side is uppermost.
- (2) Refer to Fig. 1 in this Service Bulletin. You will see that the routing of the wire links does not go over the solder pads. You must follow the same routing when you fit the links.
- (3) There are eight resistors to be added to the PCB and these are fitted on the solder side of the PCB in the positions shown in Fig. 1. The resistors and the wire links are bonded to the PCB using Loctite adhesive Tak Pak 382. Fit the resistors first and the wire links second.

NOTE: Solder the links to the metallised sides of the resistors as shown in Fig. 1. Use a surface-mount soldering iron with a controlled tip temperature between 240°C and 300 °C. The diameter of the tip must not exceed 1.5mm and the solder wire diameter must be 26SWG or less.
