Ultra Electronics SERVICE BULLETIN

SERVICE BULLETIN No. C8E38-75-001

BLEED VALVE CONTROL UNIT

INTRODUCTION OF BVCU TYPE NUMBER C8E38-12

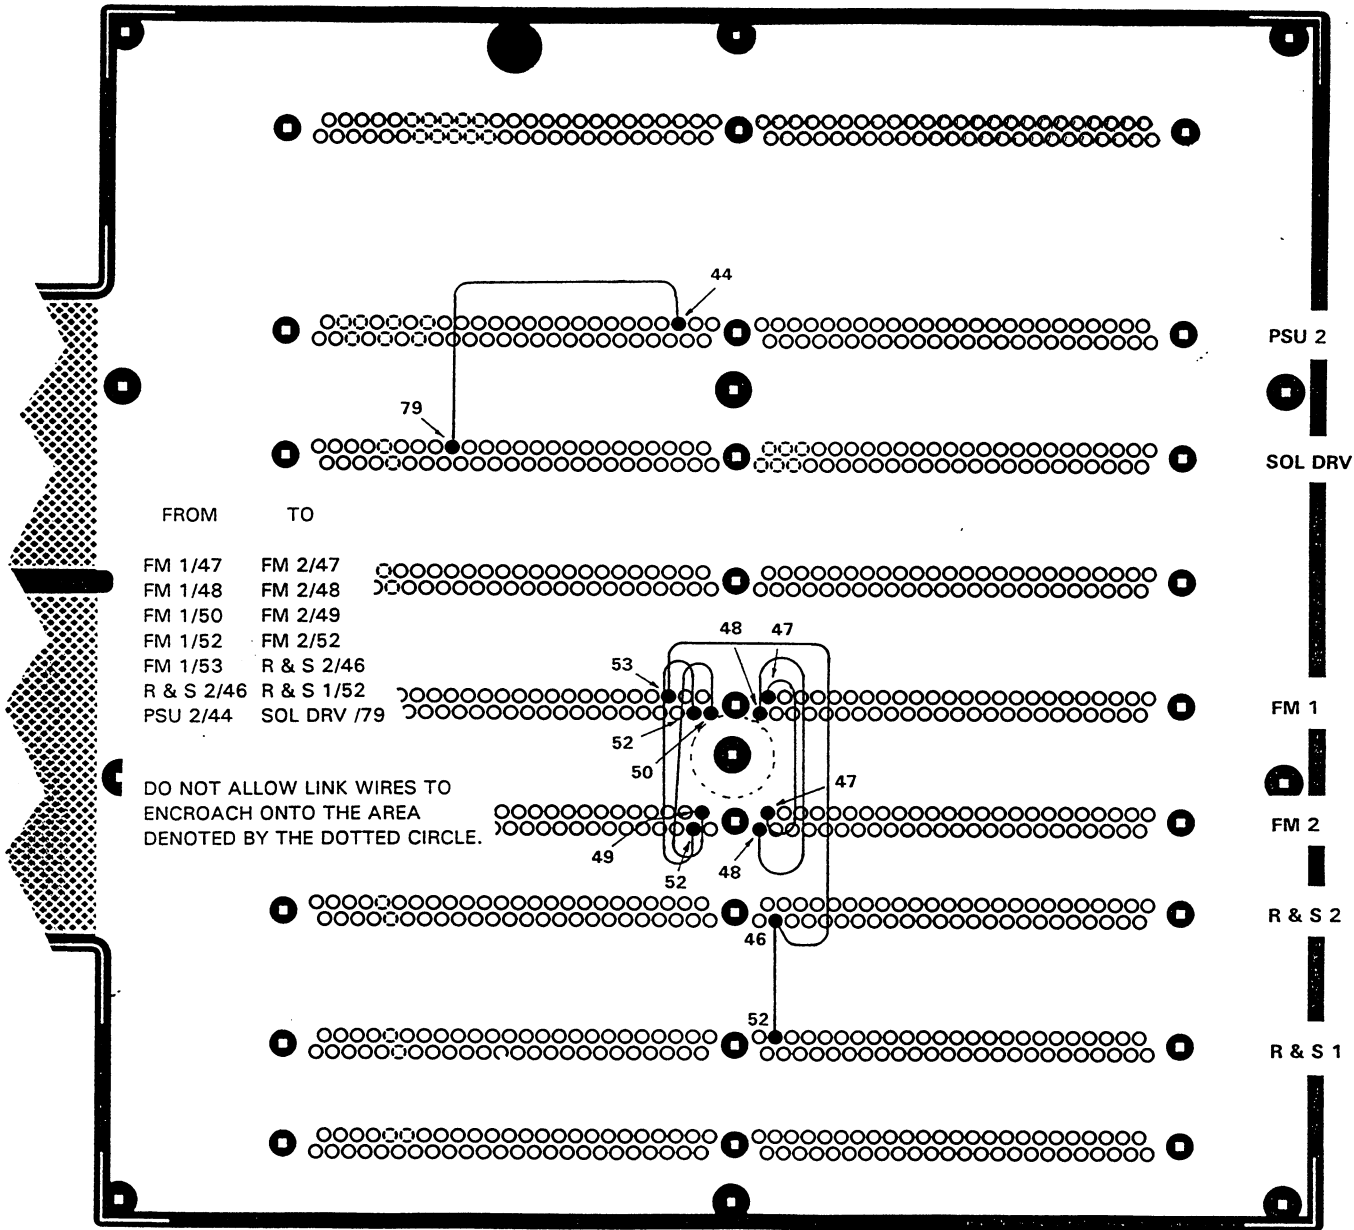
Location of Motherboard Links
Figure 1

- (1) Refer to Fig. 1 in this Service Bulletin. On the motherboard, locate and identify the pin connections listed in the table in Fig. 1.
 - (2) Refer to CMM 75-32-02, Repair page 601 and up, and familiarise yourself with the procedures for soldering work on conformally coated boards.

- (3) After removing the conformal coating locally around each pin connection, make up a set of links using Raychem Type 44, 7/0.0063 wire, Part No. 44A702926 (or its equivalent). Form the stripped ends of each link into tinned hooks of a size to fit over the protruding connector pins.

- (4) Solder the links to the connector pins, ensuring that a good fillet of solder is formed around each hook.
 - (5) Using Dow Corning adhesive RTV 3145 (or its equivalent), tack each link to the motherboard surface at frequent intervals.
