SERVICE BULLETIN No. C8E38-75-002

ENGINE AIR - COMPRESSOR CONTROL - BLEED VALVE CONTROL

BLEED VALVE CONTROL UNIT

INTRODUCTION OF BVCU TYPE NUMBER C8E38-14

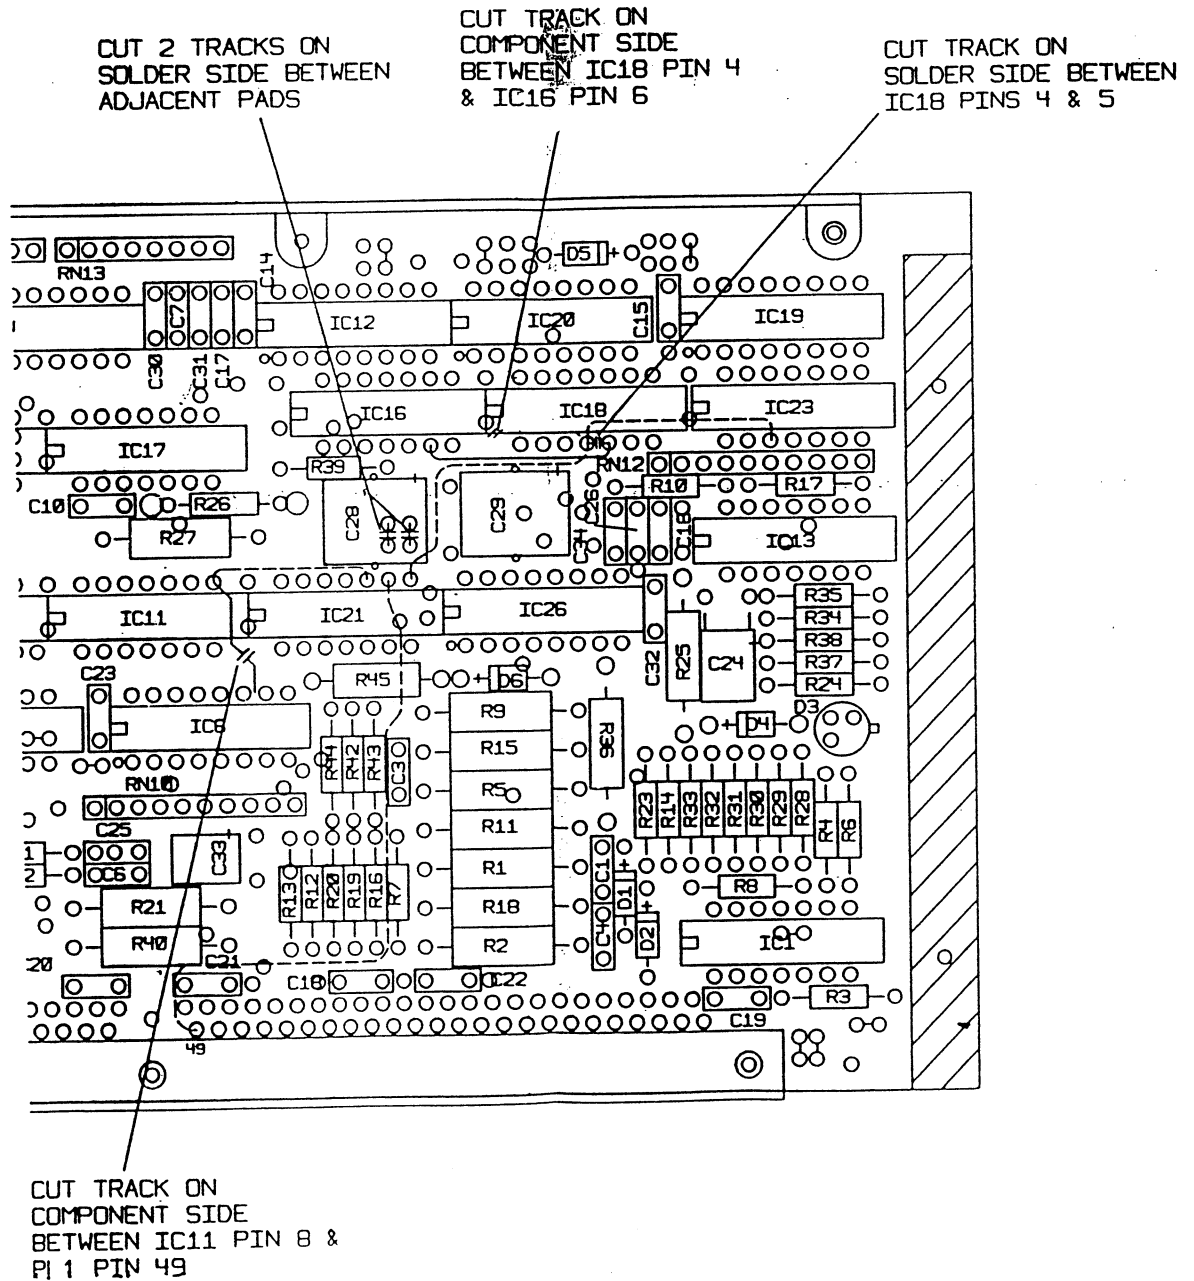
Modification of R & S 2 PCB
Figure 2

Within the BVCU, this change is accomplished by a modification to the Rate and Scheduling 2 Board (R&S2). The override EPROM, IC24, which controls operation of the HP2 solenoid is loaded with a modified schedule. This logically inverts the sense of the HP2 drive signal at pin 13 (DQ2). It also ensures that the HP2 solenoid will be driven open in the event of certain internal failures occurring.

B. Modify the R & S 2 PCB (see Fig. 2)

- (8) Refer to Fig. 2 and identify the five places on the PCB where tracks have to be cut.
- (9) Using an approved tool, cut the tracks in the five places you have identified. Ensure that you remove all swarf.
- (10) Refer to Fig. 2 and identify the five links which are to be added. These are all on the solder side of the PCB and are :

- (11) Remove the conformal coating locally around each of the 10 points listed above.
- (12) Using wire from the Mod.Kit, cut the links to size and form them as shown in Fig. 2. Note that the links must not cross over solder pads on the PCB.
- (13) Solder the links in place.
- (14) Using Dow Corning adhesive RTV3145 (or its equivalent), tack each link to the PCB at about 25mm intervals.
- (15) Remove and discard the original PCB labels and fit new labels from the Mod. Kit. Endorse the S/N label with the original serial number of the PCB. Endorse the Pt. No. label with the new part number, 016-CE-00-0020.
- (16) Repair the conformal coating as detailed in CMM 75-32-02, Repair, page 605. Add a layer of conformal coating over the new labels.
- (17) Store the modified R & S 2 PCB in an anti-static bag until you are ready to install it into the BVCU.

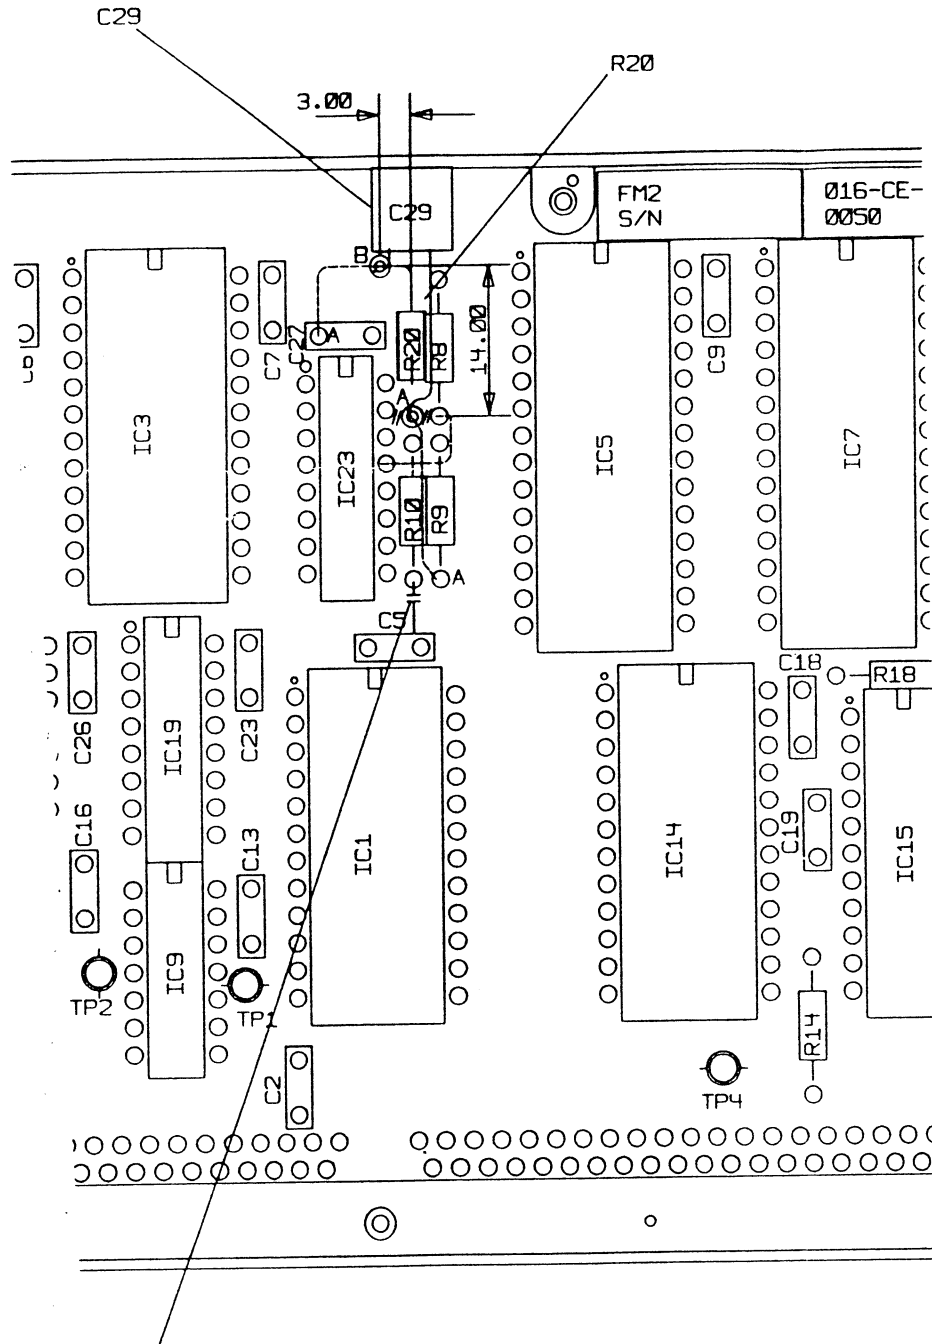
Modification of FM 2 PCB, Pt. No. 012-CE-00-0010

This involves the addition of an R/C noise filter on the Fault Monitor 2 Board (FM2) at the HP2_CUR_MON input. This does not affect the functionality of the FM2 board and will ensure that no spurious code 79s are generated

- (3) Erase the program and re-program, using the latest issue of PL Document 016-CE-00-0057.
- (4) Refer to Fig. 3A and identify the three places where the PCB tracking is to be cut.

- (5) Using an approved tool, cut the tracking in one position to isolate the R10 pad. Ensure that you remove all traces of swarf.
- (6) Cut the tracking in a further two positions to isolate the R12 pad. Ensure that you remove all traces of swarf.

- (7) Remove the conformal coating locally, as required, in the work areas.
- (8) Obtain the pin, Pt. No. K3334-753-0-8, from the Mod. Kit and fit it in position 'A' (Fig. 3A).

- (9) Drill a 1.98mm (± 0.05 mm) diameter hole in position 'B' (Fig. 3A). Remove all traces of swarf.
- (10) Obtain the pin, Pt. No. 23352-656-0-8, from the Mod. Kit and fit it in position 'B'.

- (11) Obtain capacitor C29 and resistor R20 from the Mod. Kit.
- (12) Fit C29 and R20 as shown in Fig. 3A. C29 must be bonded to the PCB using Dow Corning adhesive RVT3145 (or its equivalent). In addition, the lead of C29 which is soldered to pin 'A' must be sleeved using sleeving from the Mod. Kit.

- (13) Refer to Fig. 3A and identify the three links which are to be fitted. These are all on the solder side of the PCB and are :

- (14) Using wire from the Mod. Kit, cut the links to size and form them as shown in Fig. 3A. Note that the links must not cross over solder pads on the PCB.

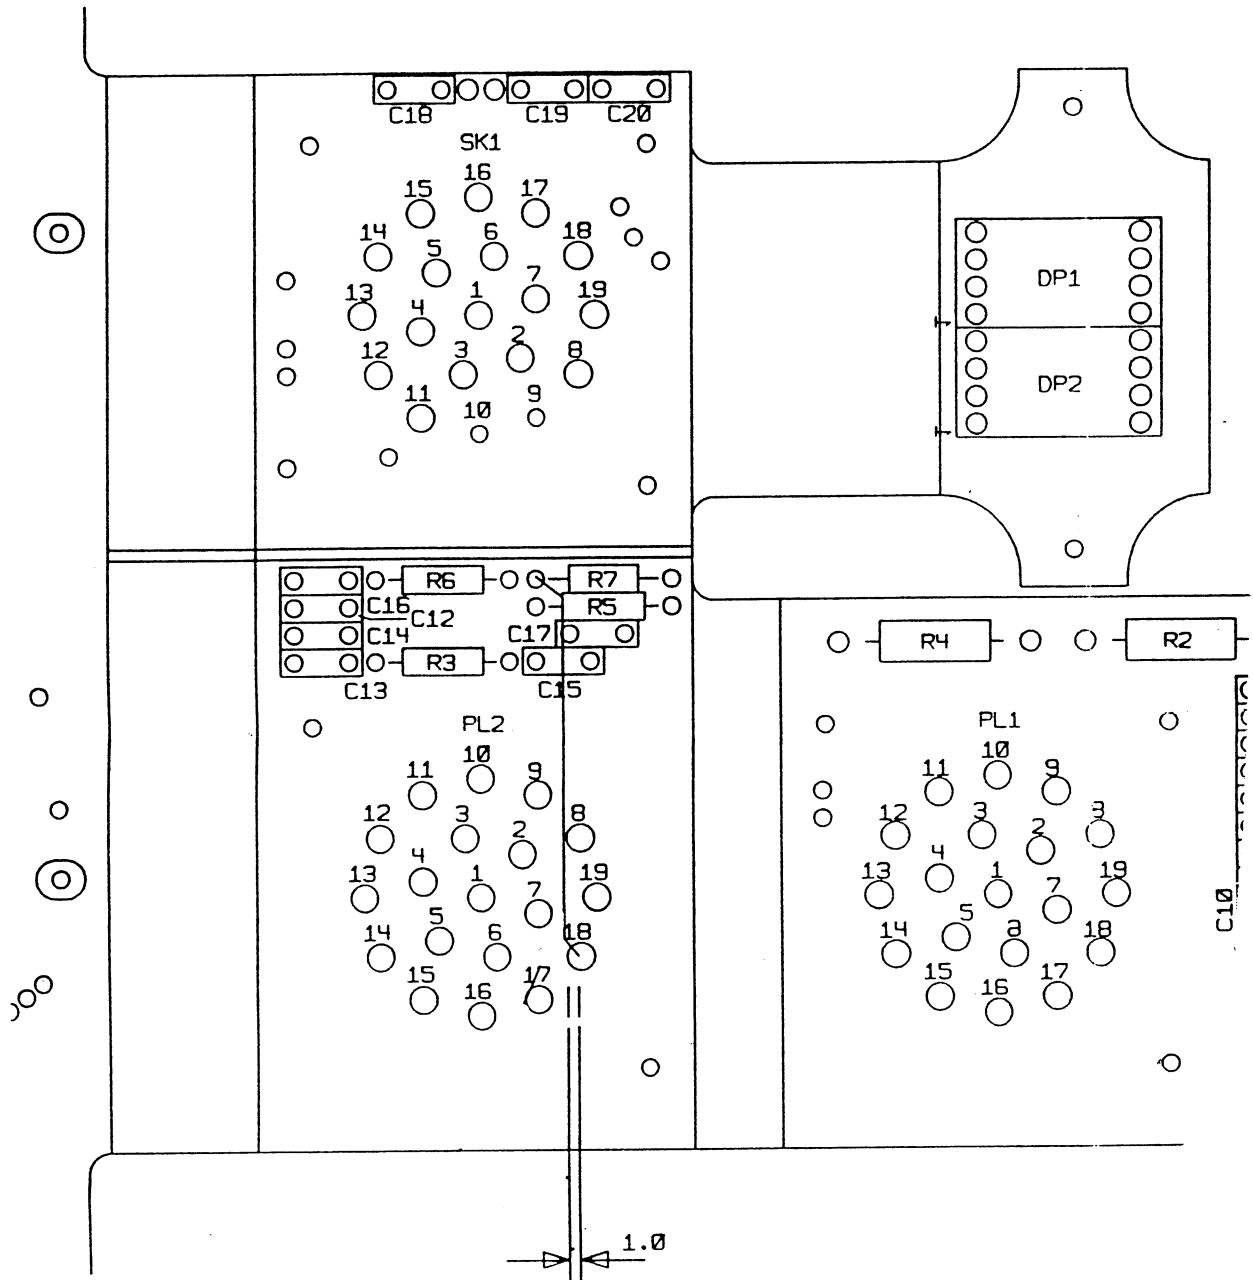
Modification of Motherboard and Flexi-Rigid Assembly
Figure 4

Because of changes to the engine wiring resulting from the HP2 solenoid drive inversion, it has become necessary to ensure that unmodified BVCUs are not fitted to modified engines. This has been achieved by a wiring change on the motherboard/flexi-rigid assembly. The GROUND CHECK selection input now enters the unit on pin 18 of the front panel connector PL2, instead of pin 17.

D. Modify the Motherboard and Flexi-Rigid Assembly (Fig. 4)

- (1) Refer to CMM 75-32-02, Repair, page 601, and familiarise yourself with the procedures for soldering work on conformally coated PCBs.
- (2) Refer to Fig. 4 and locate resistor R7 and pins 17 and 18 of PL2.

- (5) Remove the conformal coating locally as required in the work areas.
- (6) Using an approved tool, cut the PCB tracking between R7 and pin 17 of PL2, in the position shown in Fig. 4. Ensure that all traces of swarf are removed.

- (7) Using a continuity tester, check that an open circuit exists between R7 and pin 17 of PL2.
- (8) Obtain the link wire from the Mod.Kit. Trim and form it as shown in Fig. 4, so as to link R7 to pin 18 of PL2.
